NVR vs. Conventional type - Component Comparison

Clutch Disc & Cover

2 AISIN Clutch Characteristics

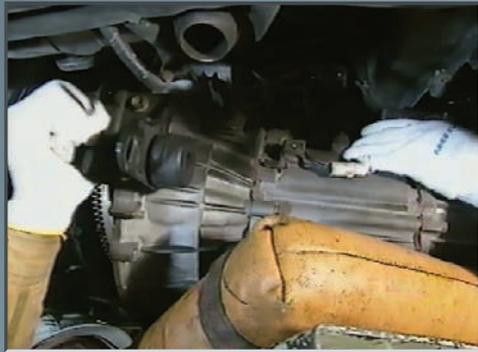
1 Use caution in the disassembly of the transmission and clutch components from the engine.

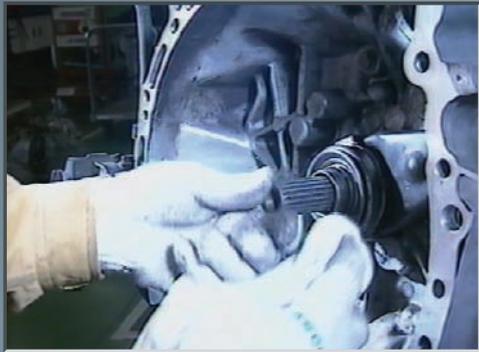
2 Clean the Input Shaft.

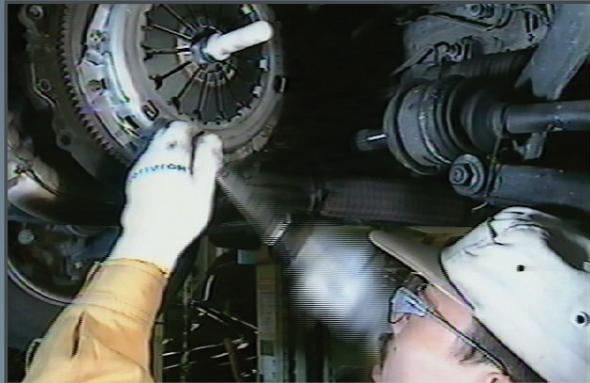
4 Use the clutch alignment tool to locate the clutch disc with the input bearing while tightening the clutch cover bolts. Tighten bolts with torque wrench in a diagonal (star) pattern.

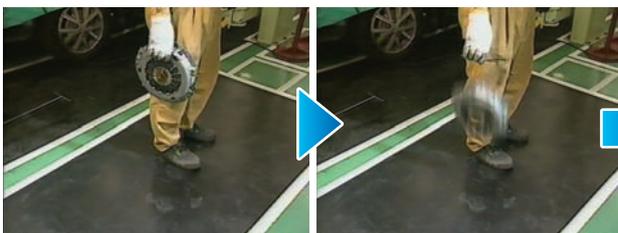
Do not drop clutch components.

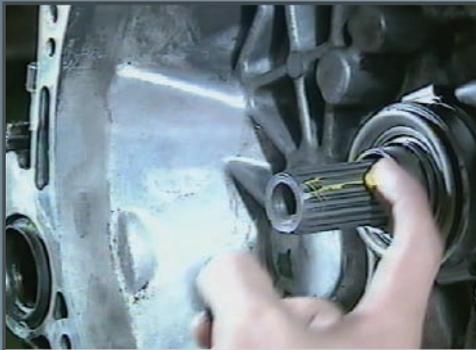
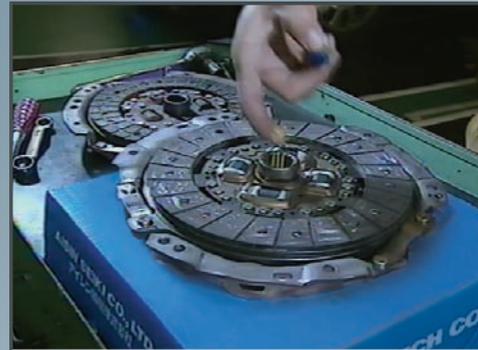
3

Apply appropriate amount of grease on the input shaft and disc spline.

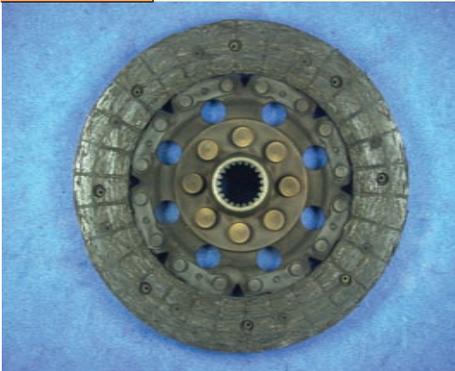
Condition: Facings are worn.

1. Facings have reached the end of its wear life.
2. Facings have been scorched due to excessive partial clutch engagement, excessive 2nd gear starts, or excessive downshifting, etc.
3. Improper driving method.

1. Improve driving method.
2. Replace disc and cover with new parts.

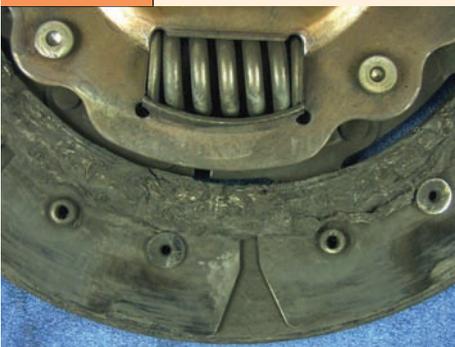
Condition: Facings have broken.

1. Facings have burst due to rapid change in torque (i.e.: mis-shifting or speed shifting).
2. Vehicle was driven with scorched facings.
3. Improper driving method.

1. Improve driving method.
2. Replace disc and cover with new parts.

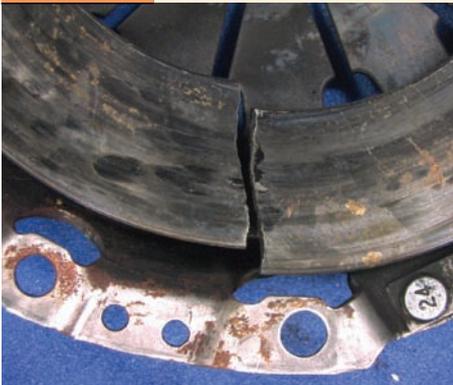
Condition: Pressure of the diaphragm spring is weak.

Disc Related Causes	Cover Related Causes	Other Causes
Cause:		<ol style="list-style-type: none"> 1. Spring function of the diaphragm spring has degraded due to heat fatigue. 2. Wrong part was installed. 3. Improper driving method. 	
Cure:		<ol style="list-style-type: none"> 1. Improve driving method. 2. Replace cover with correct part. 3. Replace disc and cover with new parts.

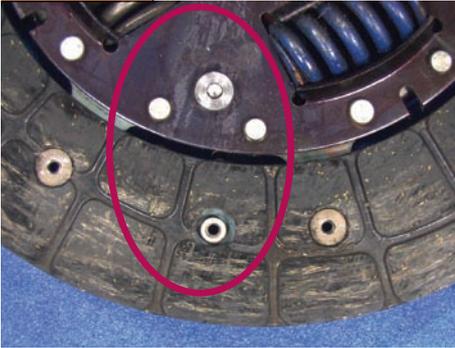
Condition: Oil or similar substance is on the friction surface of the facings.

1. Facing was touched with oily hands when replacing the part.
2. Excess spline grease was thrown onto the facing due to centrifugal force.
3. Improper installation.

1. Replace disc with new part.
2. Do not contaminate facing with oil.

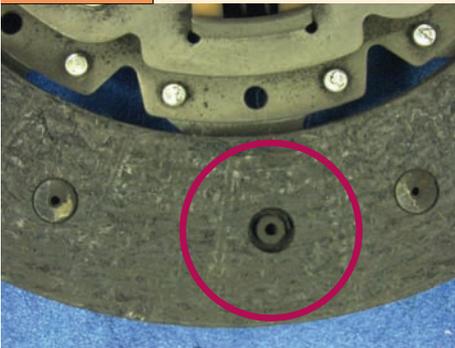
Condition: The friction surface of the facings is showing heat degradation.

1. Facing has reached the end of its wear life.
2. Facing has been scorched due to excessive partial clutch engagement, excessive 2nd gear starts, or excessive downshifting, etc.
3. Improper driving method.

1. Replace disc and cover with new parts.
2. Improve driving method.

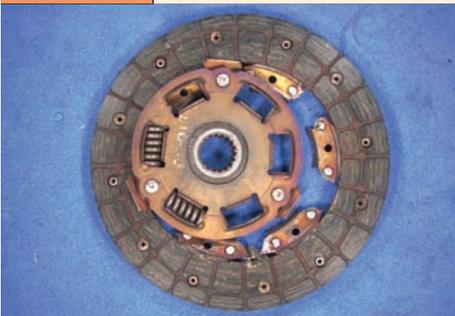
Condition: 2. Broken disc component.

Disc Related Causes	Cover Related Causes	Other Causes
Cause:	1. Misalignment caused disc to break and engine power is not being transmitted. 2. Installation error.		
Cure:	Replace disc and cover with new parts.

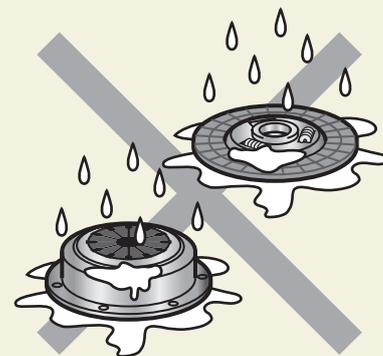
3. Product handling

Do not use a clutch that was contaminated with water or oil.

Oil on the friction surface or rust caused by water could lead to problems (e.g. clutch drag or slipping).

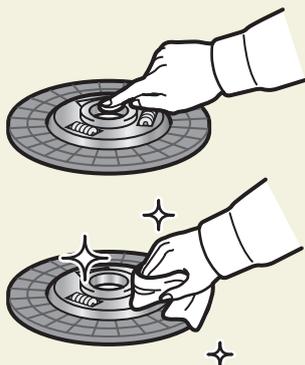
4. Disc Installation

Remove excess grease when installing disc.

Excess grease on the friction surface can cause slipping or shuddering.

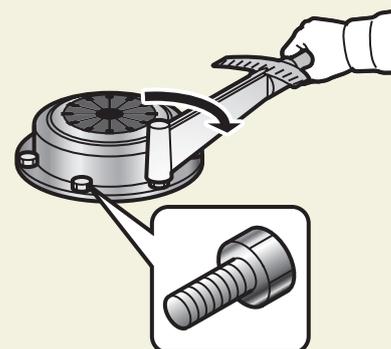
6. Cover Installation

When tightening the cover, use bolts and torque specified from the vehicle manufacturer, using a torque wrench.

Bolts can break if the vehicle manufacturer's specified bolts are not used or not tightened to torque specifications.
